# INFLUENCE OF ENVIRONMENTAL CONDITIONS AND APPLICATION OF CLEANING METHODS AGAINST BIODETERIORATION OF MARBLE MONUMENTS

P. Spathis a\*, A. Pantazidou b, M. Mavromati a, E. Papastergiadis a

**KEY WORDS:** marble, environmental conditions, biodeterioration, cleaning.

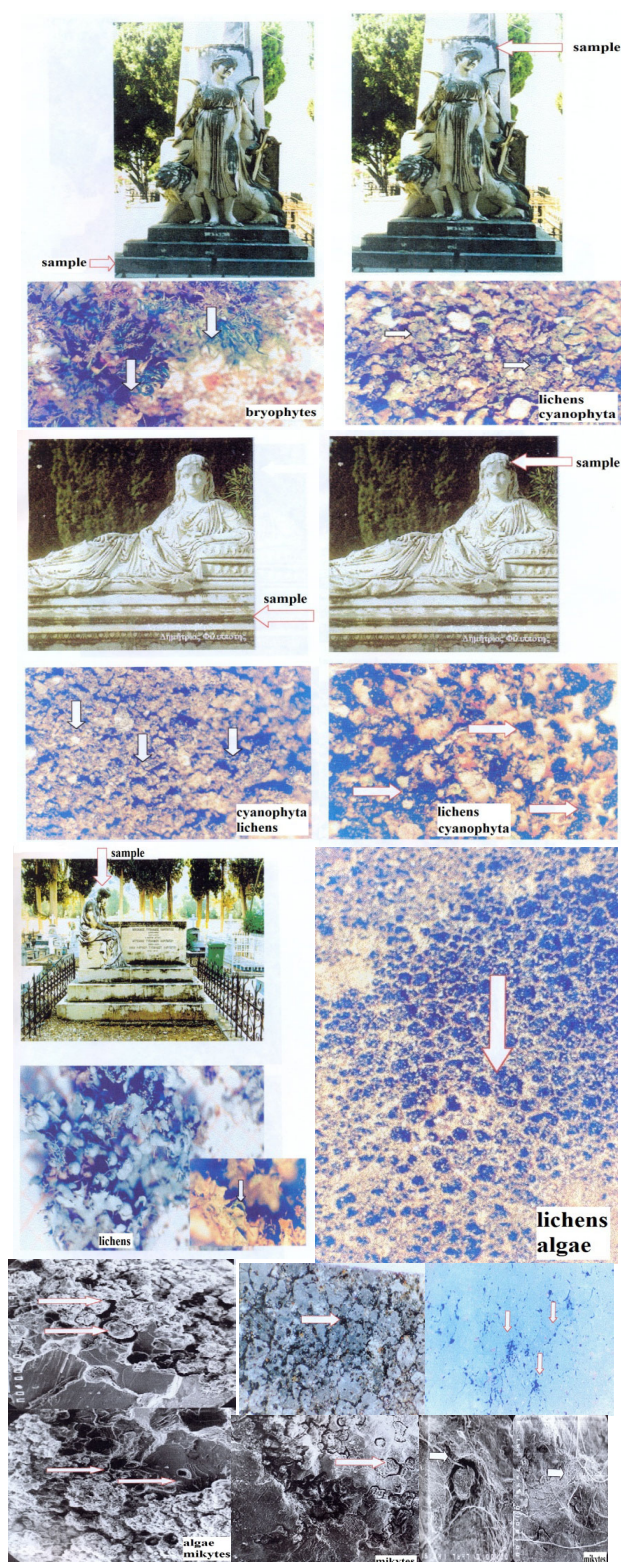
From the macroscopic observation it is obvious the presence of thick layers of biological patina, covering great parts or all almost surfaces of these. The colour of the patina varies from white, yellow, green or black. Also in some cases layers of unstable corrosion products and black crust are observed. These observations confirm that the main deterioration problem of the materials is biodeterioration, due to the growth of microorganisms, bacteria and plants, enhanced from the particular environmental conditions.

From the microscopic examination of the selected samples of microorganisms follows that the kinds found on the surfaces of the marble or in contact with it are algae (mainly cyanophyta), lichens, bryophytes, bacteria and mikytes. The determined cyanophyta are forms which often found in limestone rock located in conditions of adequate lighting, temperature and humidity and possibly moved and settled in the marble from the surroundings. Cyanophyta and lichens form on the surface of the material visible macroscopic green, orange, yellowish, brown or black overlays and coatings. The identification was based on the study of morphological traits in natural and cultivated material, (Komarek & Anagnostidis, 1986), (Anagnostidis & Komarek, 1988). The qualitative and quantitative microflora composition reveals that the study area of the cemetery with the sculptures is characterized by "eutrophic" and "oligotrophic" areas. "Eutrophic" are the positions that are characterized by a build-up of soil with slow drainage and good development of bryophytes. Such areas were found at the base of statues (terraces), on plates, trenches and wells of the structural material. These positions, since they are rich in organic and inorganic nutrients and moisture, present conditions favourable to establish and develop even higher plants in the future. The greatest variety of cyanophyta species observed is attributed to this phenomenon. In contrast, smooth, flat, dry and uniform chromatic surfaces of material are "ligotrophic" areas of the ecosystem of the monument and show little diversity and settlement of cyanophyta.

Figure 1 Sampling sites, stereoscope and scanning electron microscopy images of algae, cyanophyta, lichens, bryophytes, bacteria and mikytes found on the surfaces of the marble

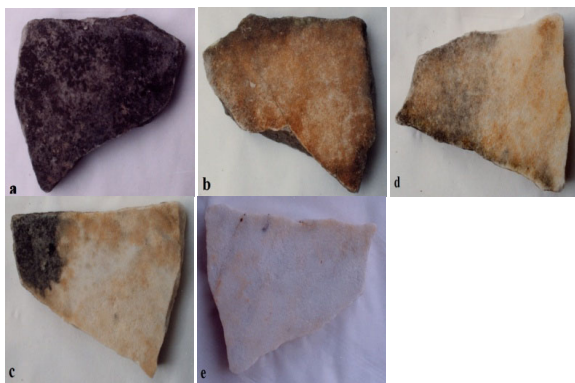
The results of the laboratory application of the various cleaning methods on a marble sample are described below. Biological patina covered all surface of the sample, as it is observed in Figure 2a, where the initial situation of the sample it is shown. For the cleaning it was applied, in part of the sample to be obvious the results of the cleaning, distilled water and organic solvents, biocide, hydrogen peroxide,  $\text{NH}_4\text{HCO}_3$ , sepiolithos and microsandblast. The application of hydrogen peroxide removed a first layer of biological patina and after that microsandblast was applied for the total removal of the patina. A kind of yellow patina is observed on the sample, due to the action of some microorganisms that have the ability to remove the ferrous ions from the bulk of the material and concentrate these in the surface where they are oxidised forming yellow ferrous oxides that they are a kind of physical patina and must not be removed. The images of the sample during the cleaning procedure are shown in Figures 2b-2d, (intermediate steps) and Figure 2e, (final situation).

Figure 2 Procedure of cleaning of M<sub>1</sub> marble sample; a: initial situation, b-d: intermediate steps, e: final situation

4. From the various mechanical and chemical cleaning methods tested in the laboratory, the best results were obtained with the use of a combination of hydrogen peroxide and microsandblast. The material of microsandblast was thin powder of small bullets (diameter 50-150  $\mu\text{m}$ ) of  $\text{Al}_2\text{O}_3$ .

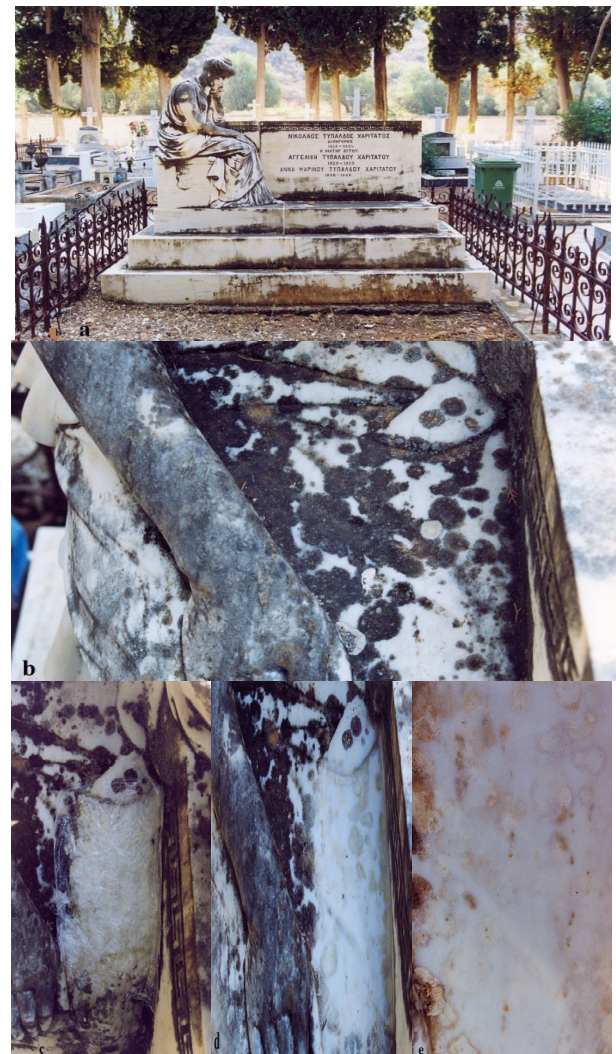
The monuments where the cleaning methods tested in laboratory experiments were applied are shown in Figures 3a, 4a and also Figures 3b, 4b, where parts of the statues with representative problems of deterioration are shown. From these figures it is obvious the presence of thick layers of biological patina of a green, blue or orange colour, covering

great parts of various areas of the statues. In some cases, layers of insoluble salts of brown colour or black crust and also deteriorated parts of the surface with cracks on it are observed. From these observations it is evident that biodeterioration caused serious problems not only on the surface of the statues but also and inside the pores of the marble.

Figure 3 In situ application of cleaning methods on a marble monument (Typaldou statue); a: general view-initial situation, b: detail-initial situation, c-d: intermediate steps, e: final situation.

The initial situation of the statue is shown in Figures 3a,b. After a mild mechanical cleaning with water, a solution of Hydrogen peroxide 10% was used for the removal of the biological patina but with mediocre results. A paste of hydrogen peroxide 25% with paper-pulp was applied for 3-4 hours in areas of thick layers of biological patina with satisfactory results (Fig. 3c). A paste of EDTA 12% was applied for 1 hour for the removal of the layers of insoluble salts and lead to a partial removal of the salts (Fig. 3d). After that the repeated application of a solution of hydrogen peroxide 25% for 5 hours had very satisfactory results (Fig. 3e).

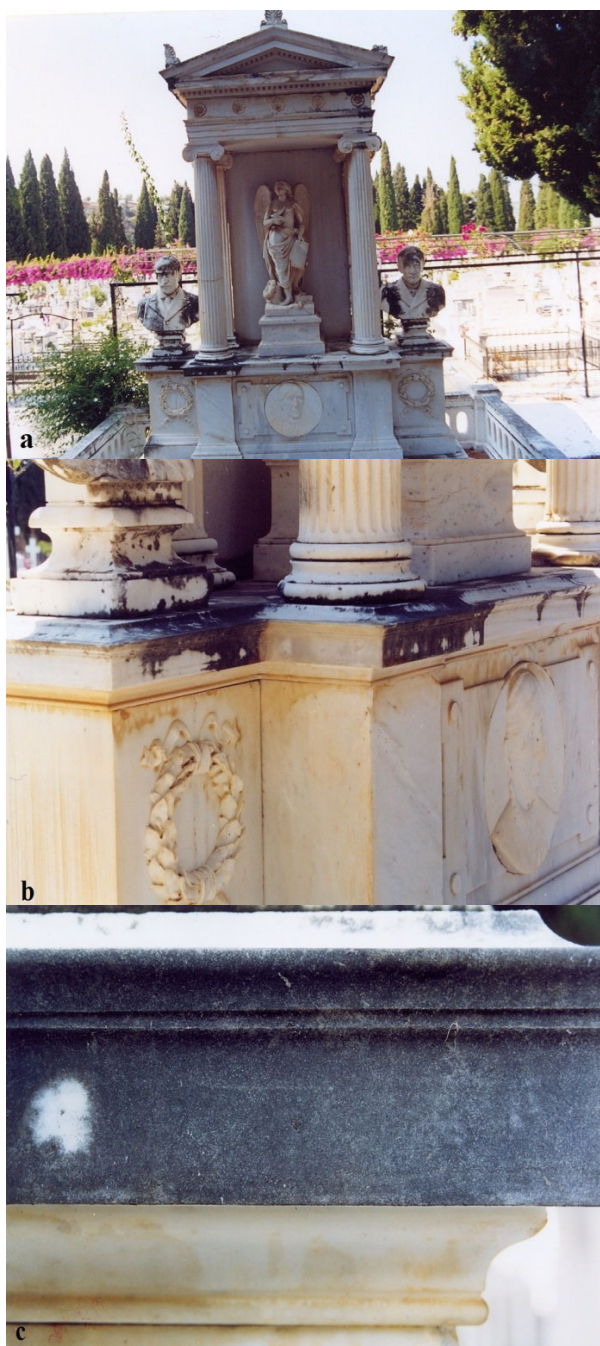
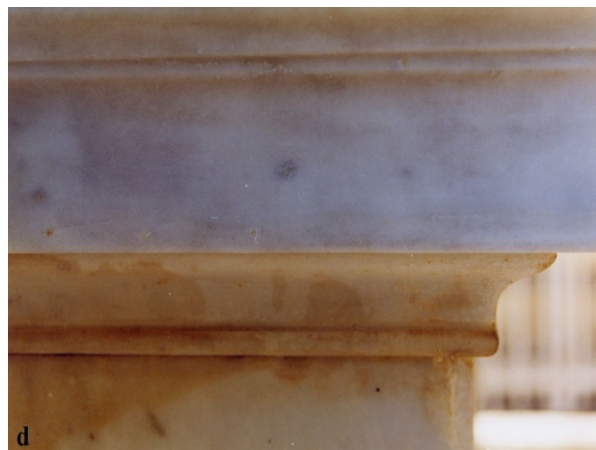
The initial situation of the statue is shown in Figures 4a,b (biological patina – black crusts). Mechanical cleaning, spaying with a solution of Hydrogen peroxide 10%, application of a paste of hydrogen peroxide 25% with paper-pulp for 5 hours and application of a paste of EDTA 12% for 2 h for the removal of black crusts were used (Figs. 4c,d)

Figure 4 In situ application of cleaning methods on a marble monument (Kosmetatos statue); a: general view (initial situation), b: detail (initial situation), c: intermediate step, d: final situation.

In the areas where the biological patina was removed, layers of a brown or yellow colour were observed that were removed after a 3 times application of a paste of EDTA 12% for 2 hours. Layers of yellow ferrous oxides, formed due to the oxidation of the mineral iron present in the marble, were observed in some areas in the lower part of the statue after the cleaning. These layers can be removed with an application of compress of a solution of thioglycolic acid 5%, neutralized with  $\text{NH}_3$  for 1-2 minutes.
